Cutting the Lake at Lady's Island

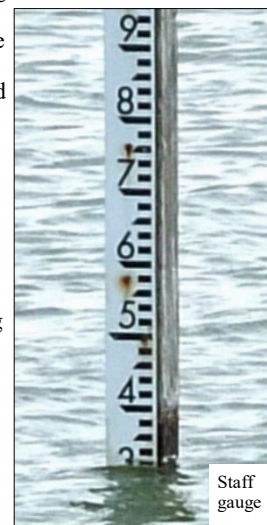
Staff gauge

Water level in Lady's Island Lake can be measured on either of two staff gauges erected near the

Community Centre in Lady's Island village. The gauges are calibrated at 0.02m (2cm) intervals and are levelled to Ordnance Datum Poolbeg (ODP). The calibration at the top of the gauges is 6.00m ODP. The level at the bottom of the gauge, that is the bed of the lake, is about 3.16m ODP. To convert from OD Poolbeg to OD Malin subtract 2.57⁷. Poolbeg is below Malin. Water level in the image is 4.32m ODP (= 1.73m ODM). The Office of Public Works (OPW) manages a data logger on the bed of the lagoon (Station No 13070) and every 15 minutes real-time water level values are uploaded from it to the OPW website at <https://waterlevel.ie/0000013070/0001/>.

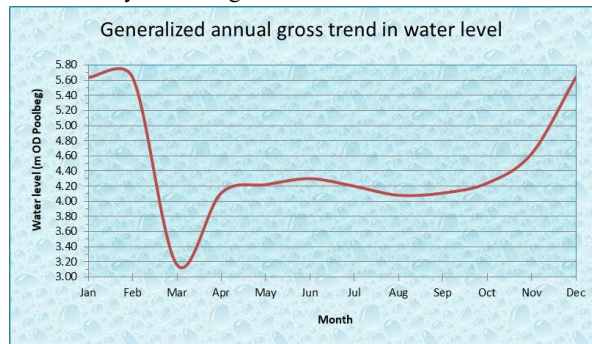
The generalized annual gross trend in water level at Lady's Island Lake is for water level to be high in winter. The highest water level recorded since September 1984 was 5.867m ODP on 29 January 2016^{OPW&8}.

The barrier is normally breached in early spring and the water level drops dramatically from its winter maximum to about 3.0m ODP, that is, slightly above mean sea level (2.59m ODP⁷). Seawater enters through the open breach on high tides and as the natural action of the sea plugs the breach the water level usually stabilises at around 4.0m ODP, slightly above mean high water of spring tides (MHWST = 3.69m ODP^{7 and 9}).

If the summer is wet, water level rises due to rainfall; if the summer is dry, water level falls due to evaporation. In the Lady's Island Lake area, October is normally the wettest month of the year⁵ so as winter sets in water level climbs steeply back to its seasonal peak to start the annual cycle over again.

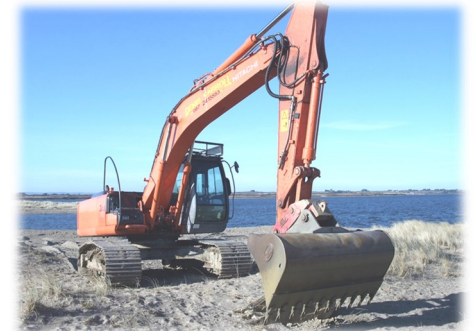
The lake is normally cut in springtime, usually during late March or early April. The breach is opened by a contractor using a track excavator. Repeated breaching of the barrier over many years has resulted in the formation, via erosion by the running water, of an exit channel on the floor of the lake. For a cut to be successful, the axis of the breach has to be aligned with that existing exit channel. The excavator aligns his machine on a line of sight joining the western tip of Codd's Inish with the steeple of the church in the village and drives across the barrier so that the machine tracks mark the axis of the leat, breach or cut.

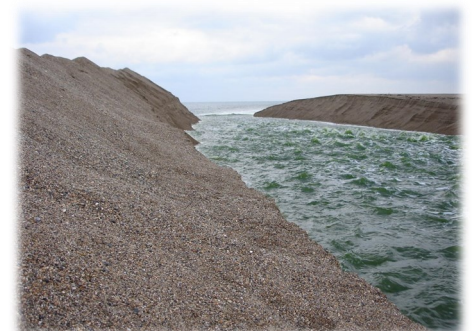
Starting work at dawn, the operator of the track excavator digs a deep trench across the barrier leaving a plug at the lake side. Gravel is piled on the eastern side of the breach. When the trench is complete the plug at the lake side is removed. Lake water pours into the trench and runs seaward. The excavator operator clears any blockages and the water runs smoothly like a river before nightfall.

Ideally, the pent-up waters are released on a falling neap tide with a northerly wind. The head of water in the lake drives the outpouring water through the breach causing water level to fall steadily. Often, a 'burst' occurs. The barrier is said to burst when the velocity of the

outpouring water reaches the threshold required to lift the underlying coarse sand and fine gravel and carry it in suspension.

Erosion increases suddenly during a burst causing very rapid widening and deepening of the breach. If and when the barrier bursts depends on a combination of factors including the head of water in the lake, the amount, if any, of winding of the breach, grain size on the barrier, the tidal cycle and the weather. The average drop in water level when the lake is cut is about 1.25m which is roughly equivalent to five million metres cubed, five billion litres or five million tonnes of water.

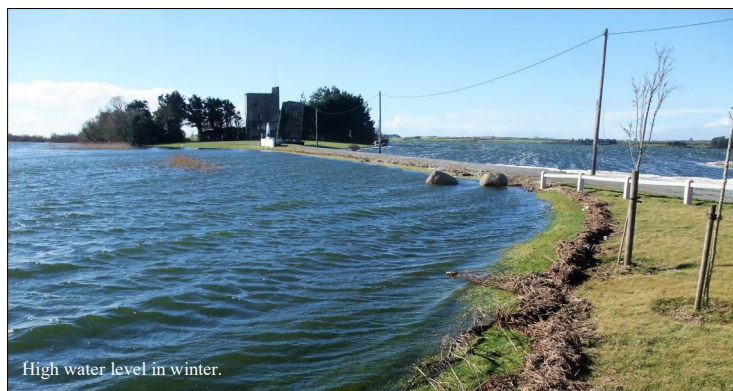
High water level in winter.
